## PROJECT DETAILS

JOB NUMBER	KEF462	INSPECTION DATE	5/07/2017
CLIENT	AGH Demolition & Asbestos Removal	REPORT DATE	5/07/2017
CONTACT NAME	Brett Gibson	CONTACT NUMBER	+61402882305
SITE ADDRESS	Jaeger 1 Building, Australian National University (ANU) - Mills Road, Acton, ACT 2601		
SCOPE OF WORKS	Encapsulation and sealing of stage two friable asbestos removal area.		
ASBESTOS CONTRACTOR	AGH Demolition & Asbestos Removal	SUPERVISOR	John coulter
ASBESTOS ASSESSOR	Ged Keane	LICENCE NUMBER	LAA001142
LEGISLATION	A thorough visual inspection of the enclosure was conducted followed by a smoke test as per section 5.2 Testing an enclosure of the Code of Practice How to Safely Remove Asbestos (2011),

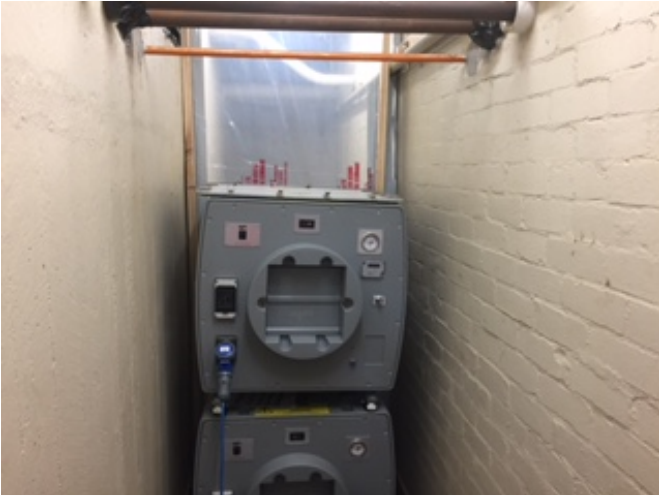
Negative pressure unit

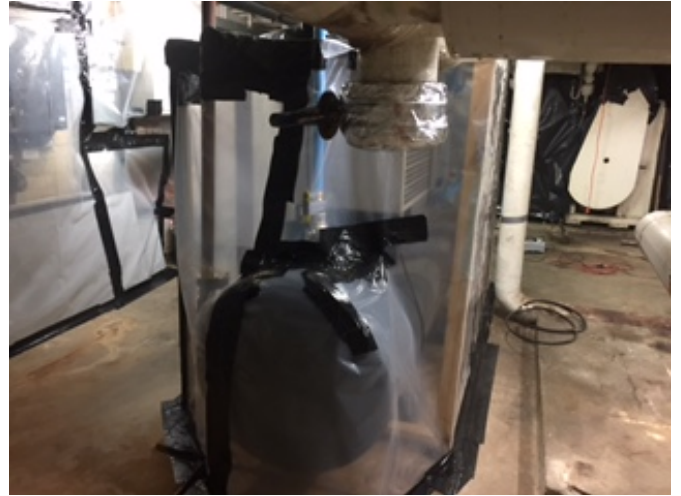
Encapsulation of boiler

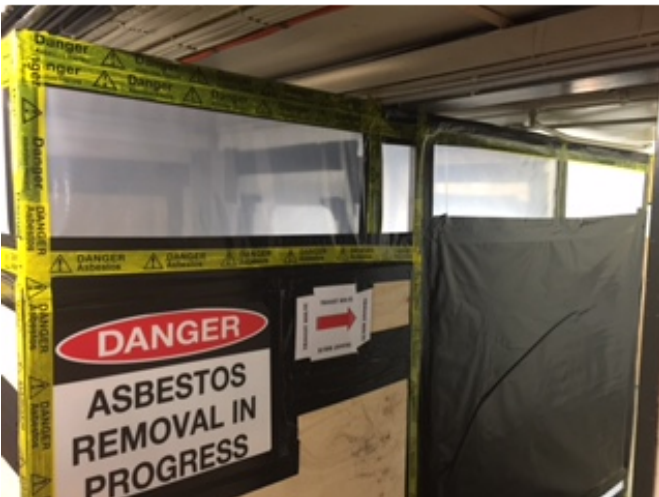
Airlock with signage and timber protection

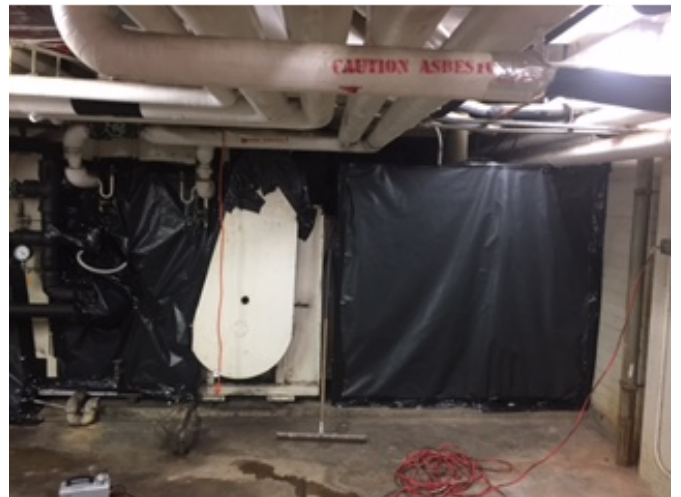
Encapsulation of Air handling unit in main plant room

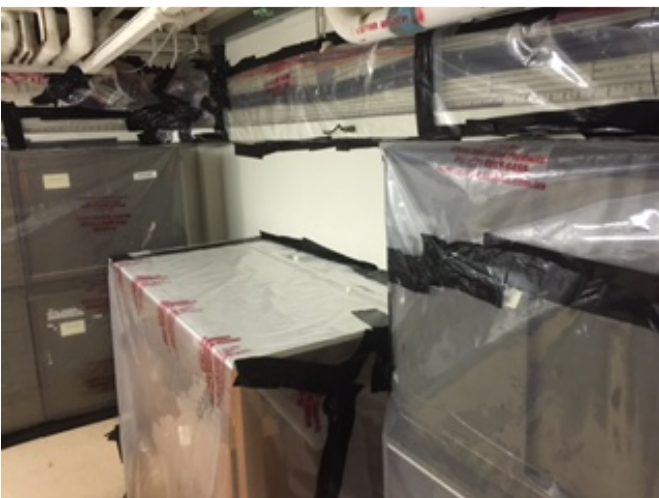
Encapsulation of internal fittings room B6

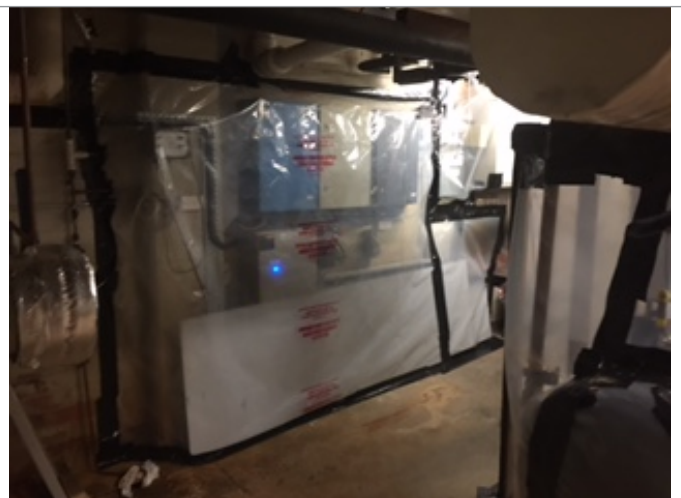
Encapsulation of internal areas in main plant room
