HAZARD ALERT

Electric shock: Entering ceiling spaces

Risk: Exposed wiring in ceiling spaces

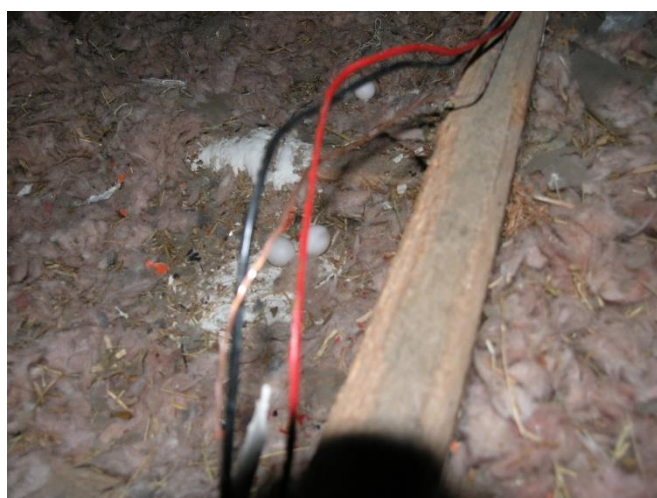
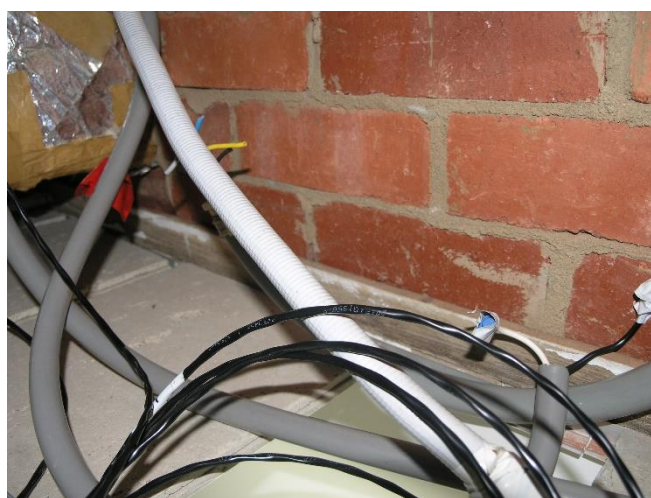
Issue: Several instances of exposed wiring have been detected in ceiling spaces at the university. The first instance was found to be caused by birds or animals entering the roof space and eating the insulation off the wiring. The second was improper termination of redundant control wiring. In both instances, there were minor injuries and Notification to Comcare was required.

- Ensure work permits are in order before work begins.
- Extreme care is required when entering roof spaces.
- Caution is required when removing ceiling tiles.
- Use a torch to inspect ceiling spaces for hazards before entering.
- Report all damaged wiring and hazards to Facilities and Services and immediate supervisor as soon as practicable.
- Test all wires for electrical current before touching
